DEPARTMENT OF TRANSPORTATION

Quality Assurance and Source Inspection

Contract #: 04-0120F4Cty: SF/ALA Rte: 80 PM: 13.2/13.9File #: 1.28**WELDING INSPECTION REPORT****Resident Engineer:** Casey, William**Address:** 333 Burma Road**City:** Oakland, CA 94607**Report No:** WIR-026765**Date Inspected:** 29-Nov-2011**Project Name:** SAS Superstructure**OSM Arrival Time:** 700**Prime Contractor:** American Bridge/Fluor Enterprises, a JV**OSM Departure Time:** 1530**Contractor:** American Bridge/Fluor Enterprises, a JV**Location:** Job Site**CWI Name:** As noted below.**CWI Present:** Yes No**Inspected CWI report:** Yes No N/A**Rod Oven in Use:** Yes No N/A**Electrode to specification:** Yes No N/A**Weld Procedures Followed:** Yes No N/A**Qualified Welders:** Yes No N/A**Verified Joint Fit-up:** Yes No N/A**Approved Drawings:** Yes No N/A**Approved WPS:** Yes No N/A**Delayed / Cancelled:** Yes No N/A**Bridge No:** 34-0006**Component:** OBG Component**Summary of Items Observed:**

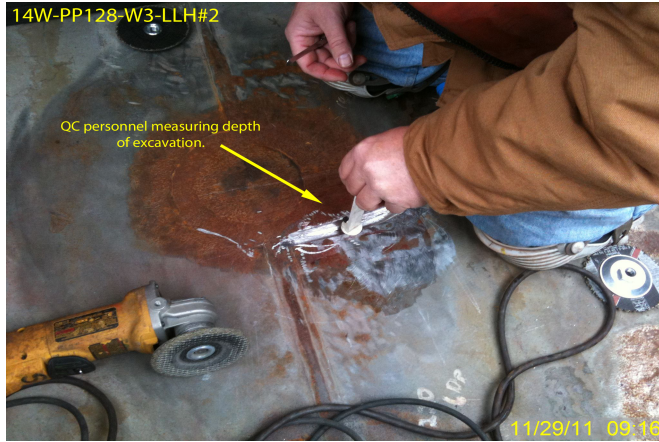
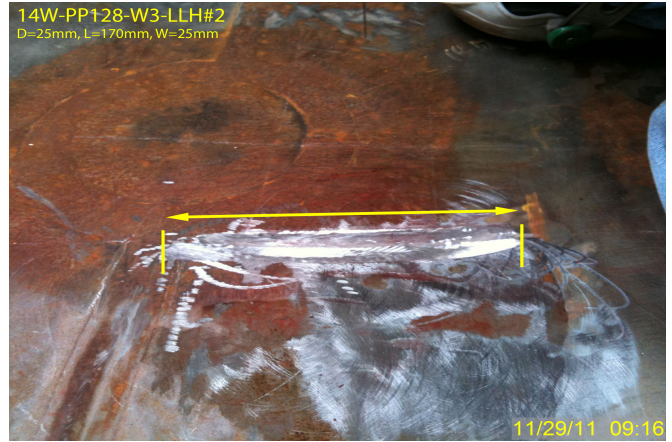
This QA observed, at random intervals, ABF/JV qualified welder Salvador Sandoval #4671 performing Shielded Metal Arc Welding (SMAW) with 1/8" diameter E7018H4R electrode and implementing Caltrans approved Welding Procedure Specification (WPS) ABF-WPS-D15-1004-R. This welding was performed to repair a base metal crack previously discovered by Quality Control personnel using the Magnetic Particle Testing (MT) method. This work was located at 14W-PP128-W3-LLH#2 and was performed in the flat position from the top of the "A" deck plate.

Arc Welding (SMAW) with 1/8" diameter E7018H4R electrode and implementing Caltrans approved Welding Procedure Specification (WPS) ABF-WPS-D15-1004-R. The joint being welded was a 20mm plate insert at the "A" deck to close the lifting lug deck penetration holes. This work was located at 14W-PP128-W4-LLH#4 and was performed in the flat position from the top of the "A" deck plate.

This welding was performed to repair a QCUT reject.

This QA observed, at random intervals, ABF/JV qualified welder Jorge Lopez #6149 performing Shielded Metal Arc Welding (SMAW) with 1/8" diameter E7018H4R electrode and implementing Caltrans approved Welding Procedure Specification (WPS) ABF-WPS-D15-1004-R. The joint being welded was a 20mm plate insert at the "A" deck to close the lifting lug deck penetration holes. This work was located at 14W-PP128-W4-LLH#3 and was performed in the overhead position from the bottom of the "A" deck plate.
